Albuquerque Bernalillo County Water Utility Authority

SUBJECT: Docket No. VI-92-1129- NPDES Permit No. NM 0022250

Albuquerque Bernalillo County
Water Utility Authority
Field Division / Collection Section
Condition Report

Re: SSO – July 10-11, 2022 – 64th-I40

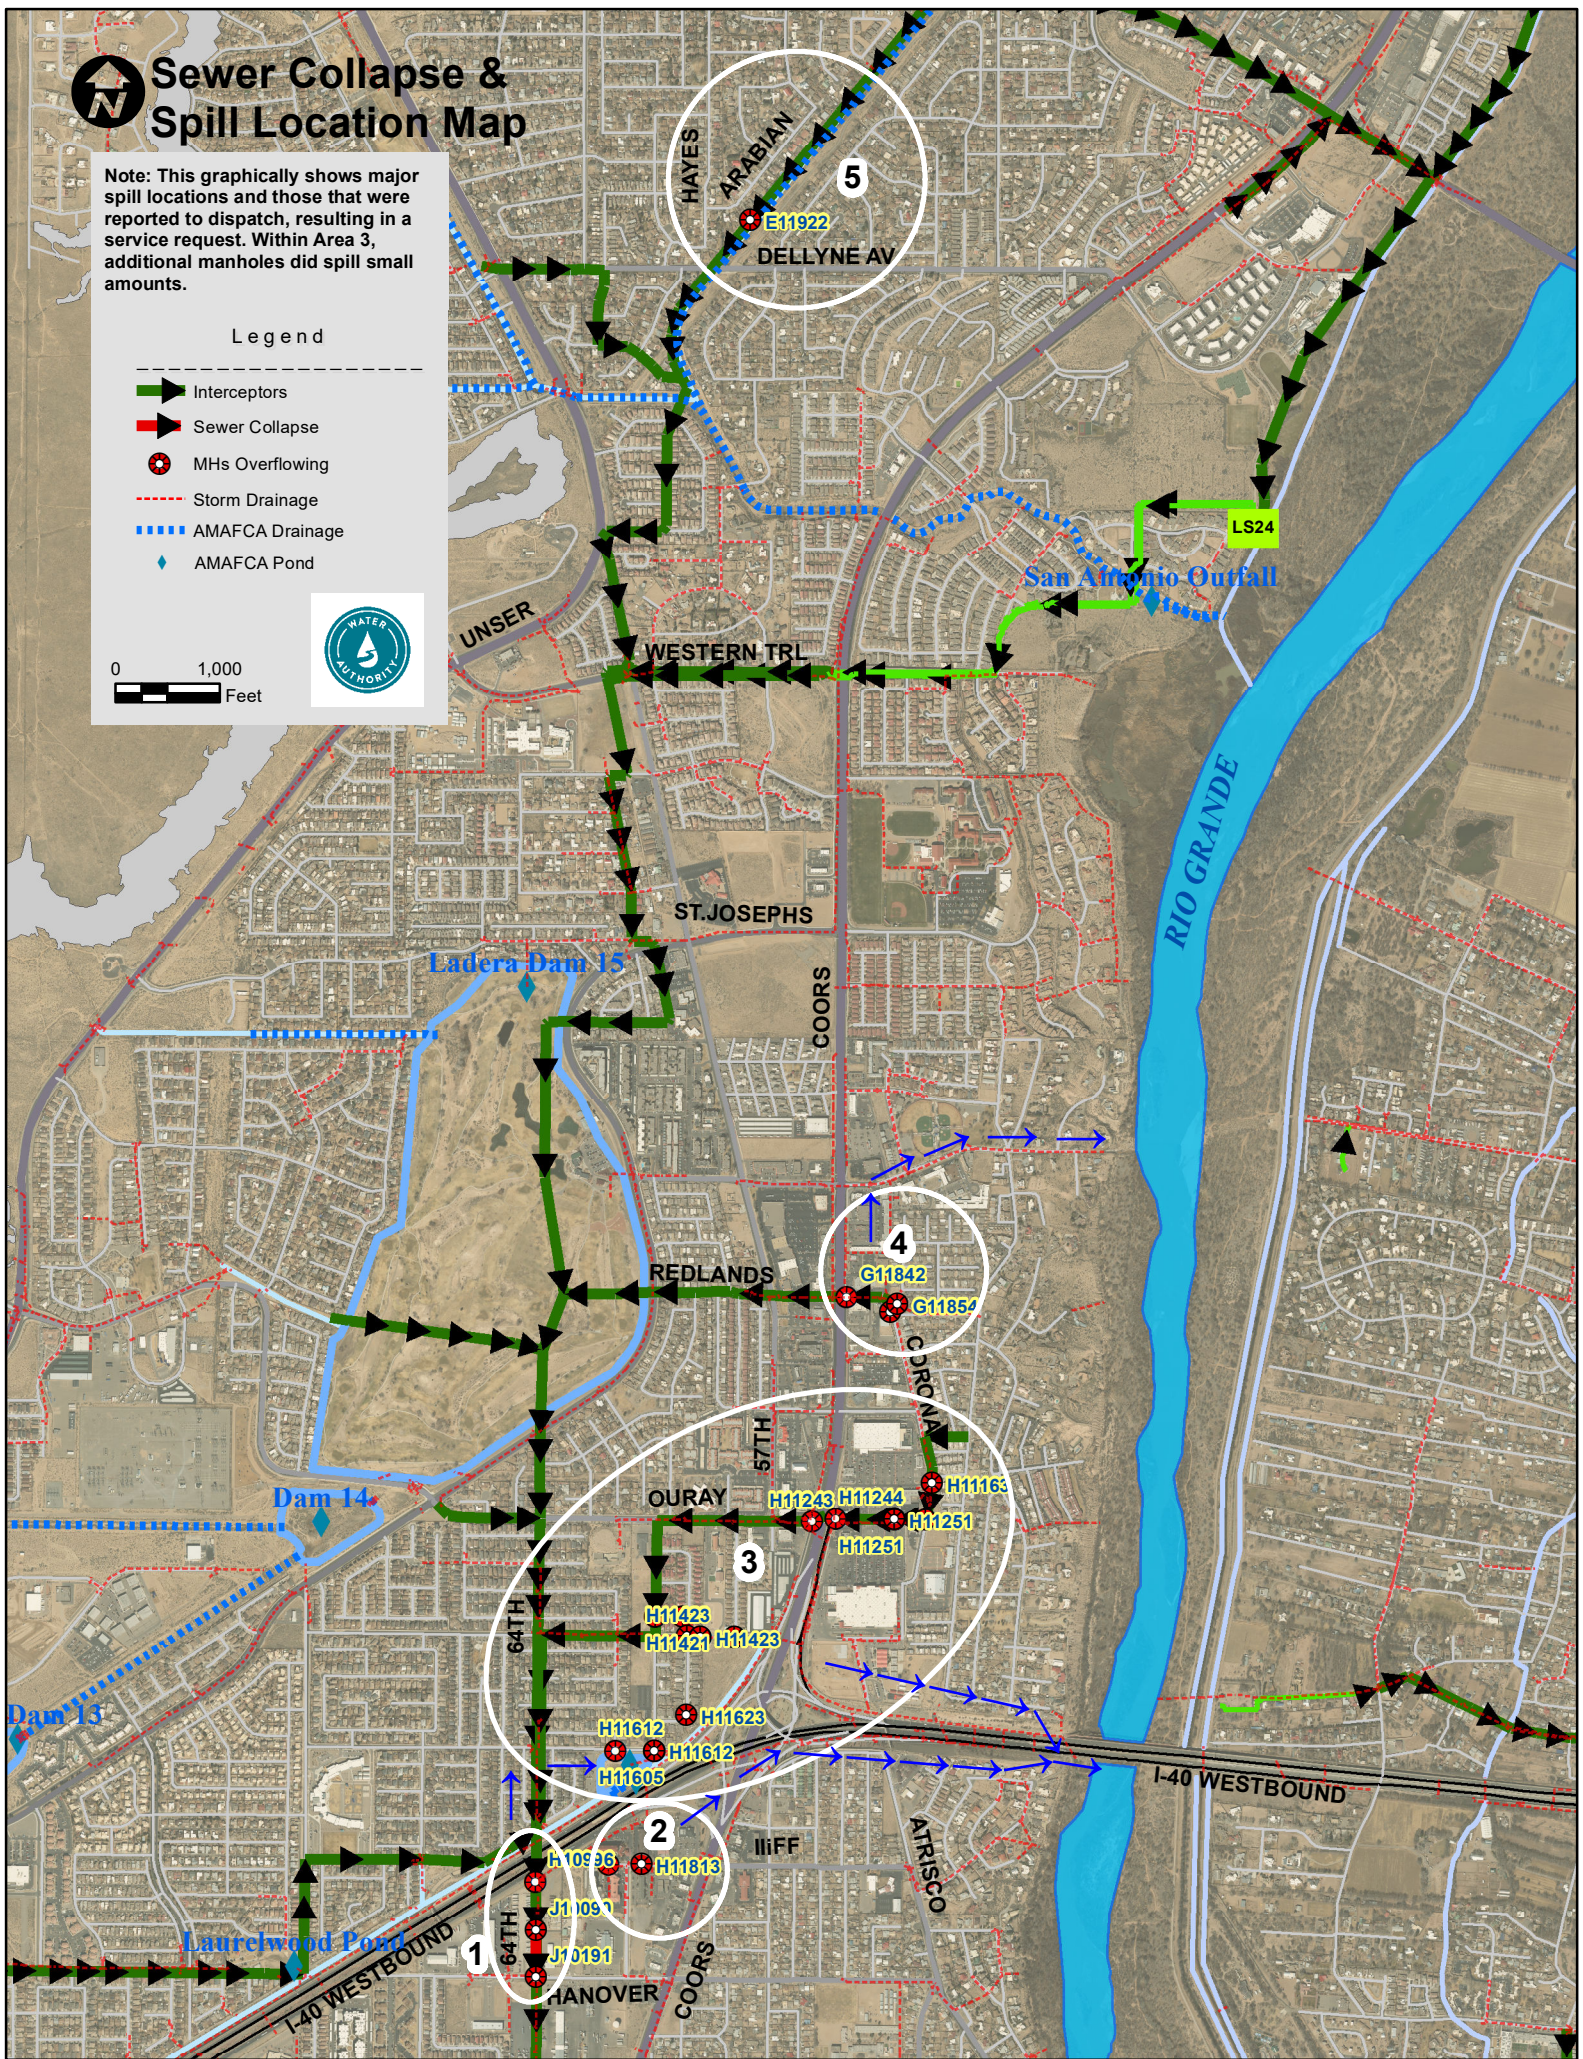
See attached Attachment A-Sewer Collapse and Spill Location Map. Segment J10-191 to J10-090 collapsed on July 10, 2022. An SSO occurs when flow is sufficiently restricted that the detained flow volume exceeds the upstream volume available in pipes and manholes below the lowest manhole rim or plumbing fixture. The SSO was first reported at 5:54 p.m. Sunday, July 10, 2022 and was caused by the collapse. The collapse occurred on an interceptor with significant flow that could not be relieved by a single spill from a single collapse point or even several manholes. Based on reports from the contractor operating by-pass pumping for a major downstream rehabilitation project, we believe that all flow in the interceptor was blocked and none continued downstream. The upstream pipe therefore continued to fill and more, and more, manholes spilled as the water level rose as the cumulative release from multiple manholes was inadequate in comparison to the upstream flow.

The spills from this SSO primarily, but not exclusively, flowed to the City of Albuquerque drainage system. Attachment A identifies five spill areas based on where the flow routed within the drainage systems. Four of the five flowed to City storm drainage systems. Table 2 - Spill Locations and Volumes provides estimated volumes in each of the areas. During preparation of this report, it was identified that two relatively small spills occurred that did not flow to the West Bluff Pond or to the discharge outlets to the Rio Grande at I40. The estimated 100-gallon spill at Area 5 is believed to have dried at the pervious area around the manhole and had no downstream impact. The estimated 54,000-gallon spill drained through the City storm pipes that route to Sequoia and then discharges to Rio Grande. I spoke with the City (David Harrison, Engineering Division Manager) and confirmed the discharge point. I inspected the discharge at 7 p.m. on July 13 and observed no indication of remaining spill or solids.

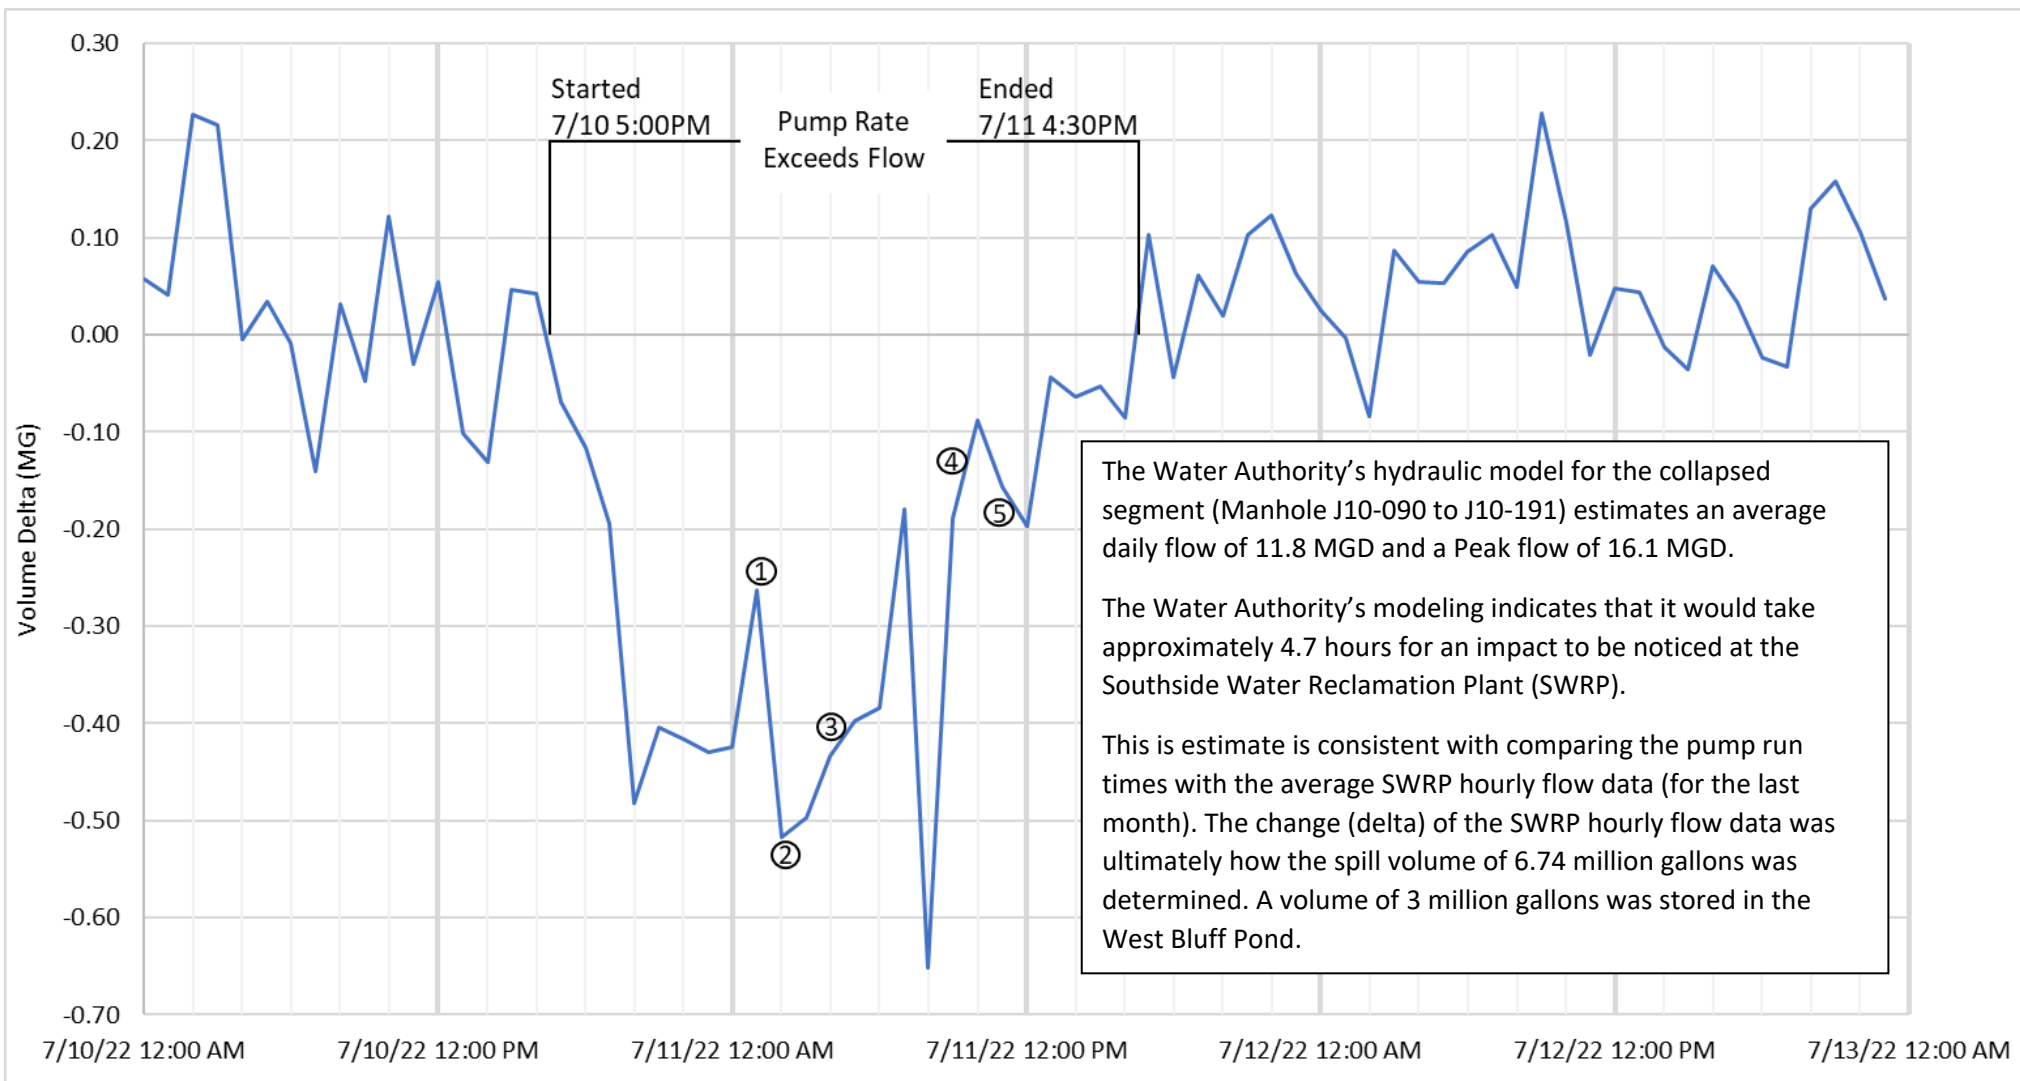
**Attachment B – SWRP Hourly Flow Data Comparison and Bypass Pumping Capacity
Table**

The Water Authority maintains accurate flow monitoring at the Southside Water Reclamation Plant (SWRP). An analysis determined that the total spill was 6.74 MG. See Attachment B - SWRP Hourly Flow Data Comparison and Bypass Pumping Capacity Table. Of this, approximately 3 MG is estimated to be held at the West Bluff Pond. The Water Authority estimate is therefore a total 6.7 MG spill with 3.7 MG reaching the Rio Grande. Table 2 provides approximate spill volumes and location in the 3-mile radius.

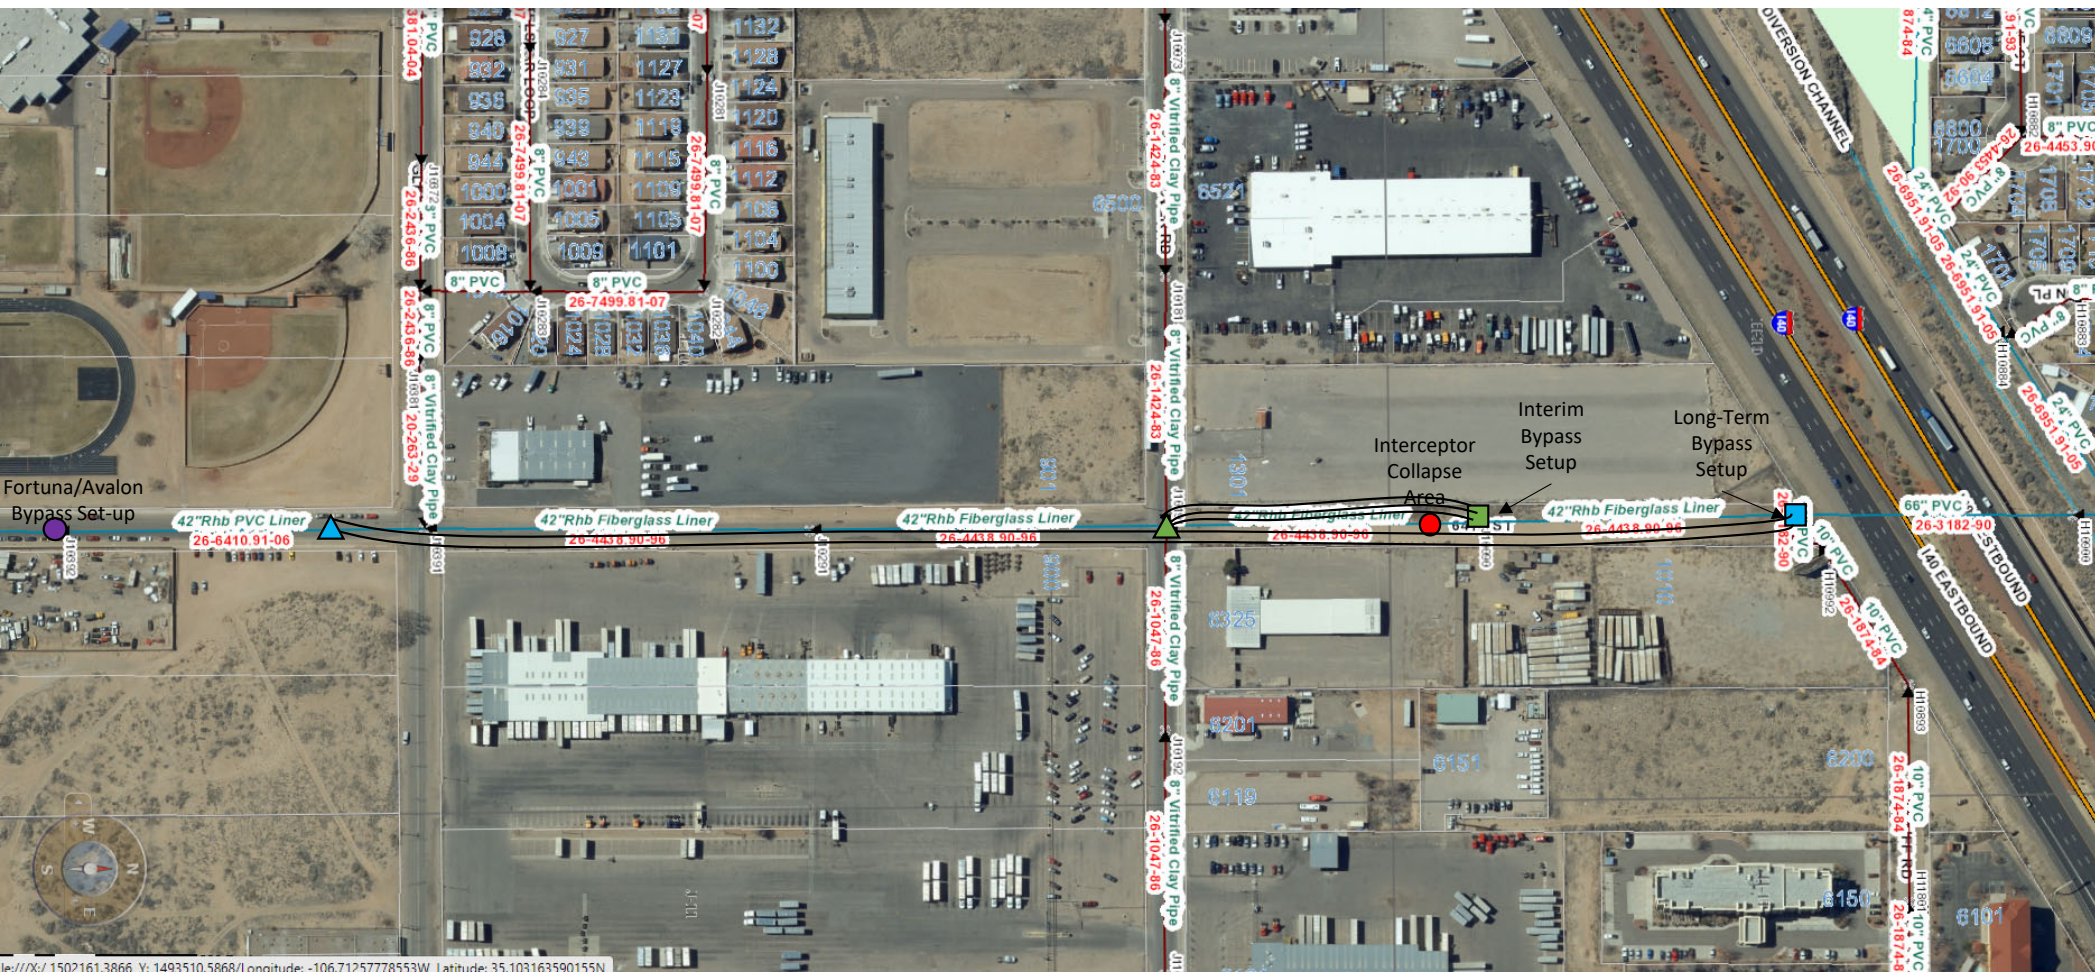
64th/Hanover Westside Interceptor Collapse - Emergency

See Attachment C - Bypass Pumping Vicinity Map which identifies the collapse location, the interim by-pass pumping installed to this point and long term by-pass that will allow rehabilitation of the pipe that collapsed.

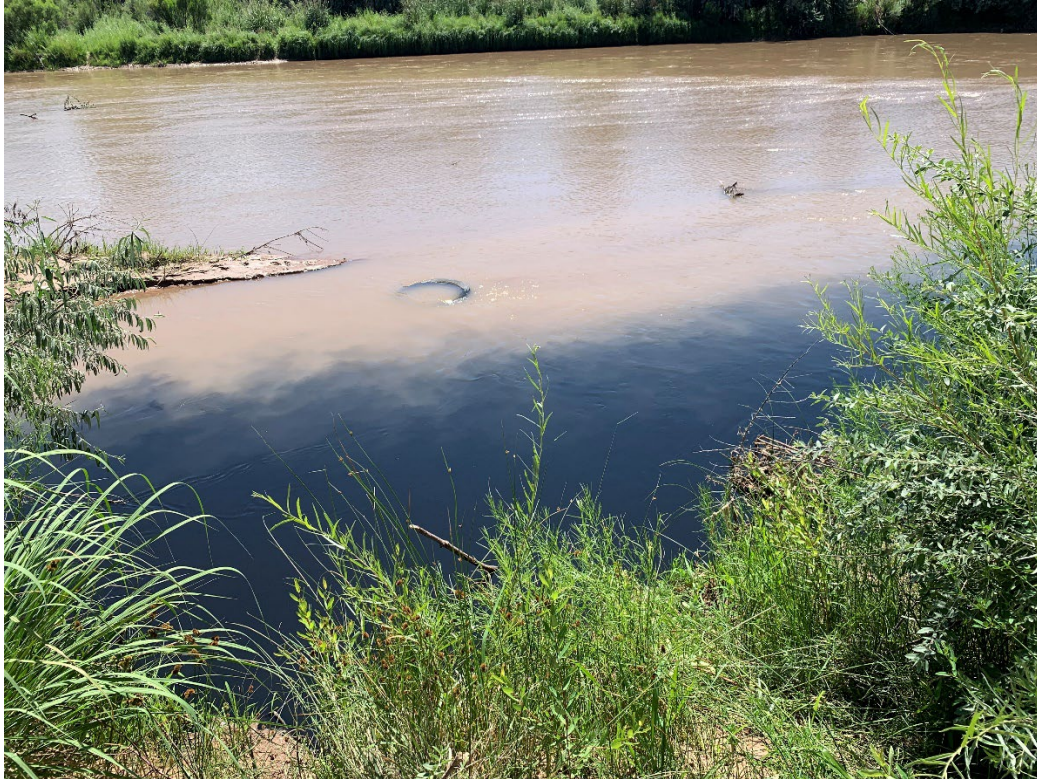
1. Storm outfall and sample collection downstream

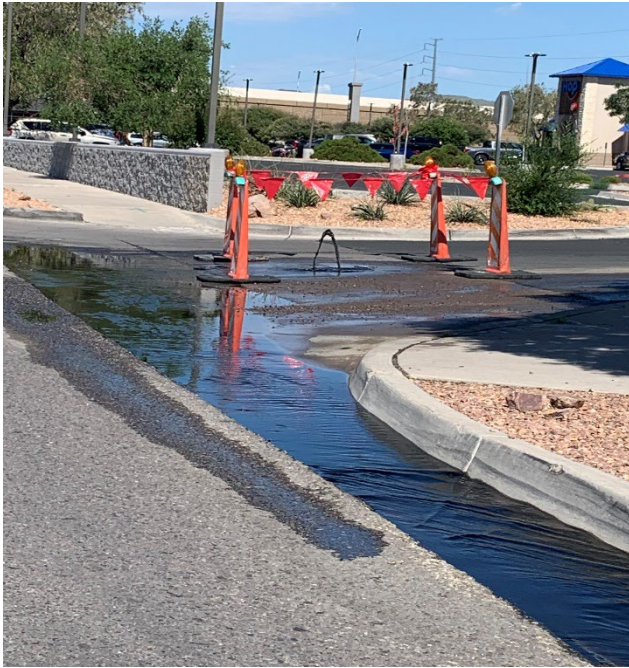
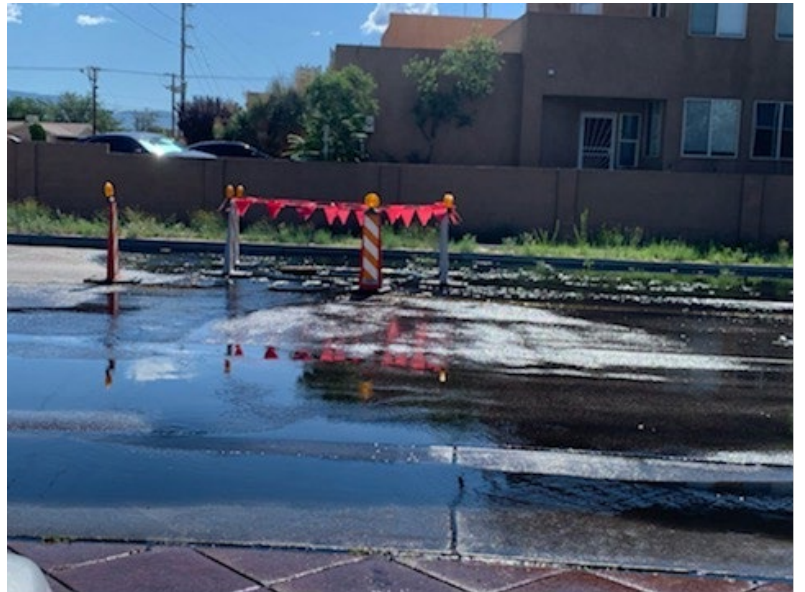
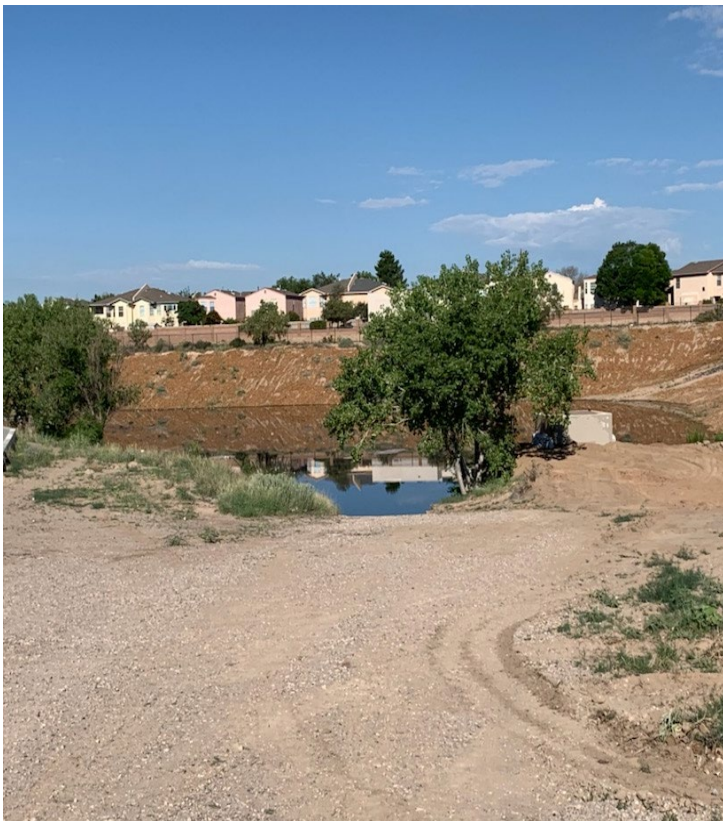
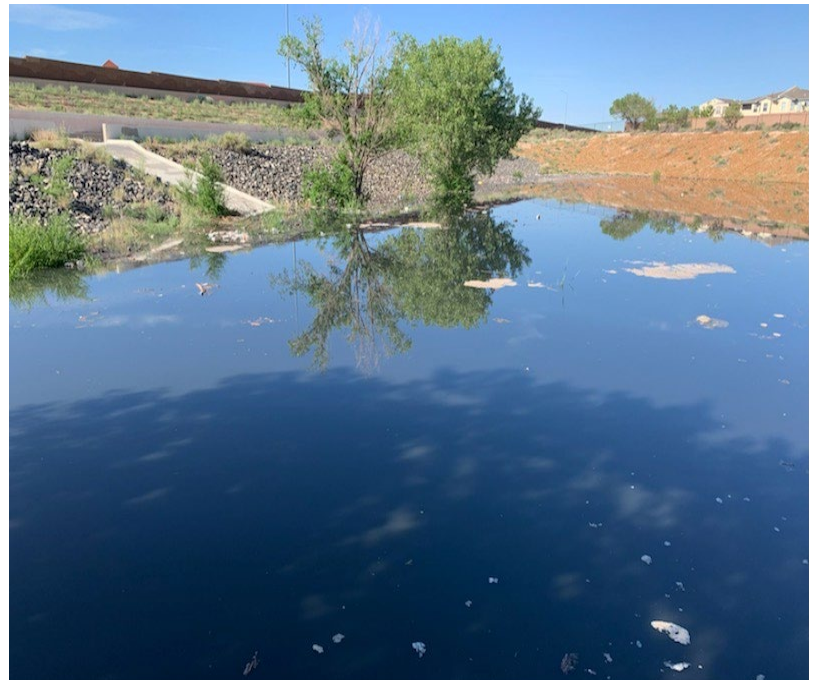
Approximately 3 MG of sewage was spilled to and contained by the West Bluff Pond. This Pond is a water quality feature owned and managed by AMAFCA. AMAFCA temporarily closed off the Pond outlet, retaining this sewage and preventing its release to the Rio Grande. AMAFCA also closed off the Pond to through-flow of storm water, however, during run-off events the pond does “float” with the drainage system and will slowly fill to an equilibrium elevation. Two storms have occurred since the sewage was trapped and slow flow into the Pond was observed during each storm event.

2. Street flow and storm pond

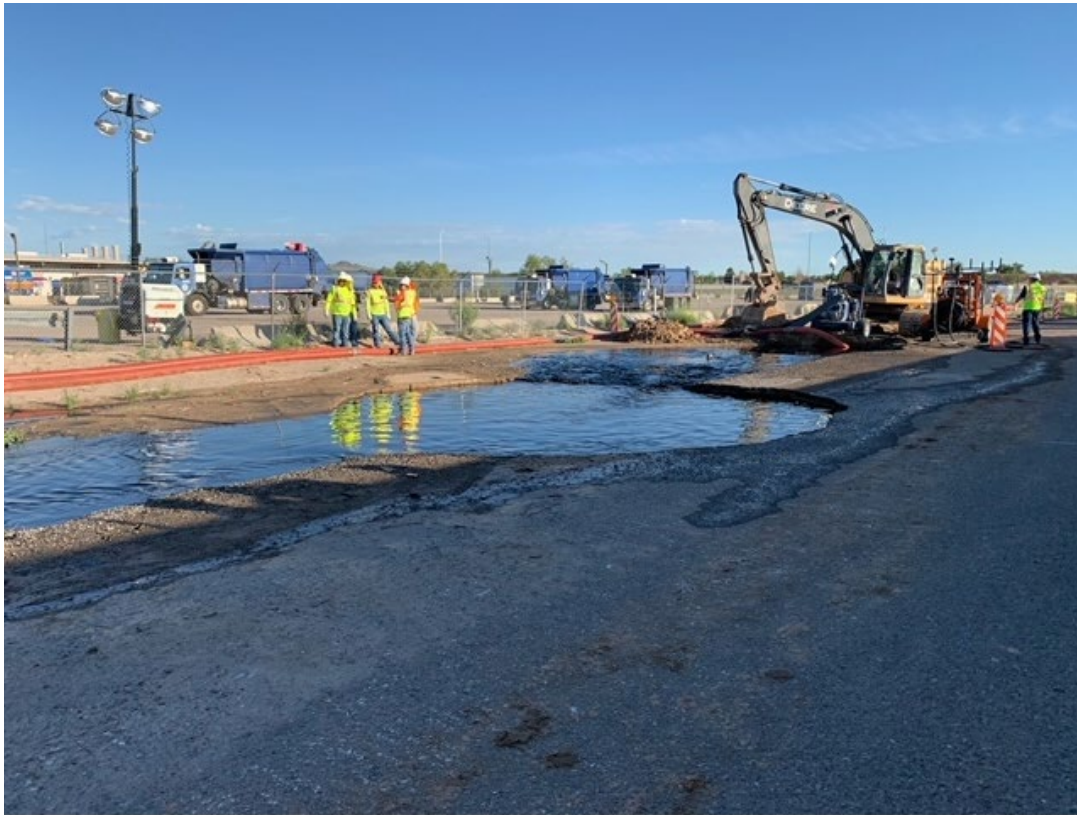
The Water Authority has initiated the rehabilitation of the immediately downstream portion of the same interceptor that collapsed. By-pass pumping commenced on July 7 for this downstream project. The Water Authority believes that this by-pass pumping surcharged the upstream interceptor that collapsed. The interceptor apparently was corroded, and surcharging saturated the soil above the interceptor. The soil lost cohesion and collapsed into the pipe, blocking all flow.

3. Sink hole

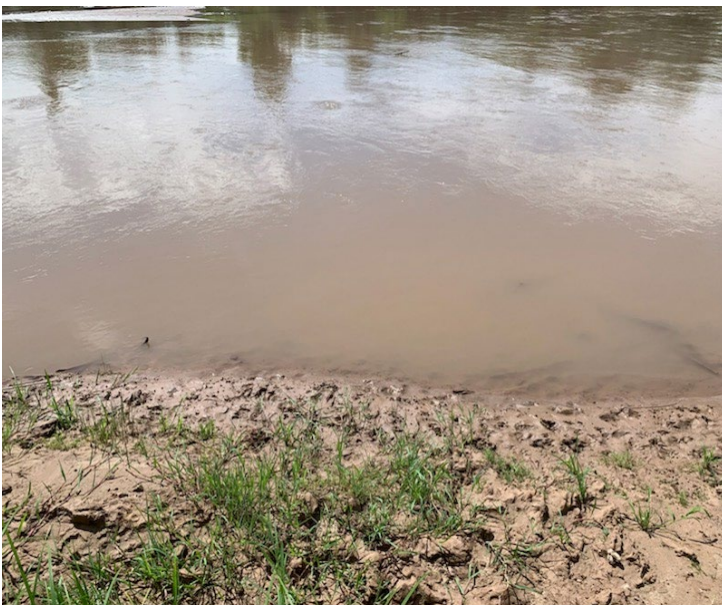
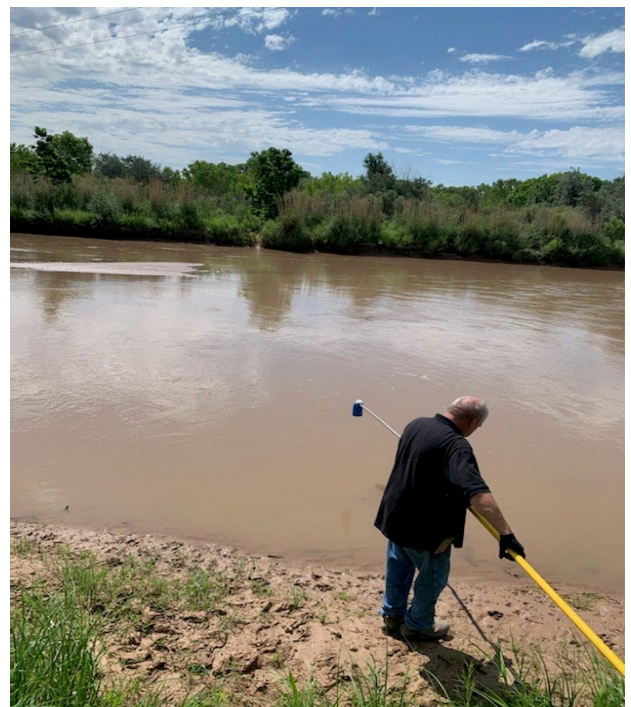
4. Tuesday July 12 Sample Collection
