Water Authority Emergency Response to Westside Sewer Collapse

Danielle Shuryn Compliance Division Manager

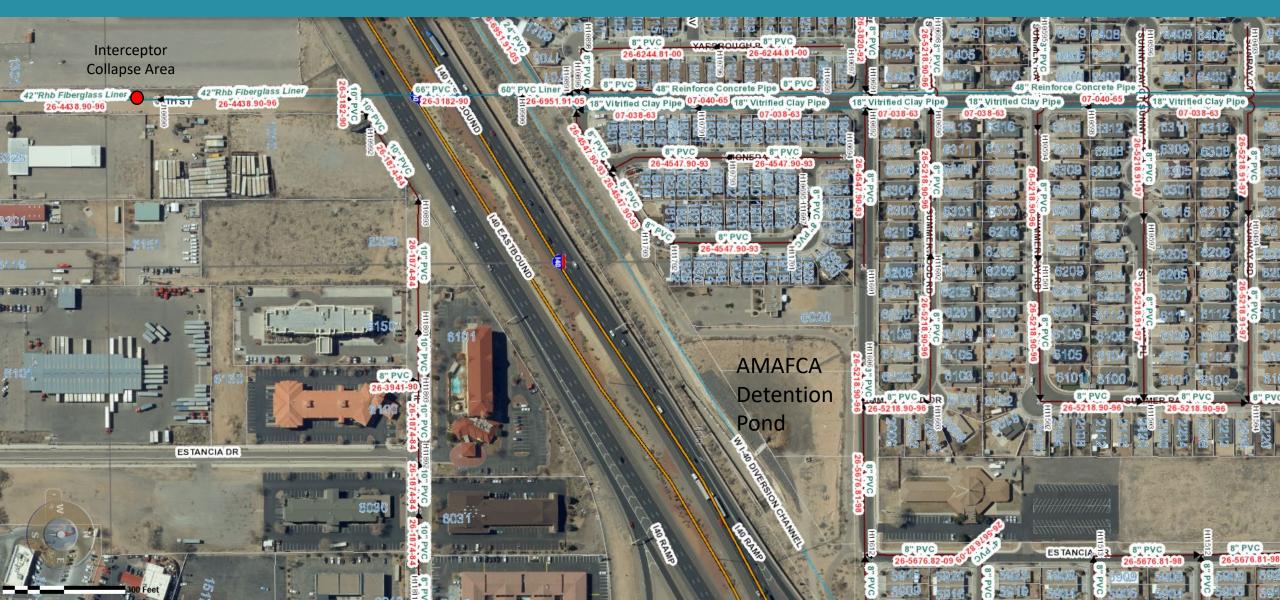
Storm Pond Map

- 12:45 AM bypass to storm pond begins
- 2:00 11:00 AM Water Authority staff and emergency on call contractors work all night to find equipment and execute the bypass so that the flow from the collapse is contained. Bypass set up is completed.
- Noon Overflow is primarily contained, and pooled wastewater clean up begins at the collapse site.
- All Day Overflow emergency response plan was executed and
- clean up began at each overflow location

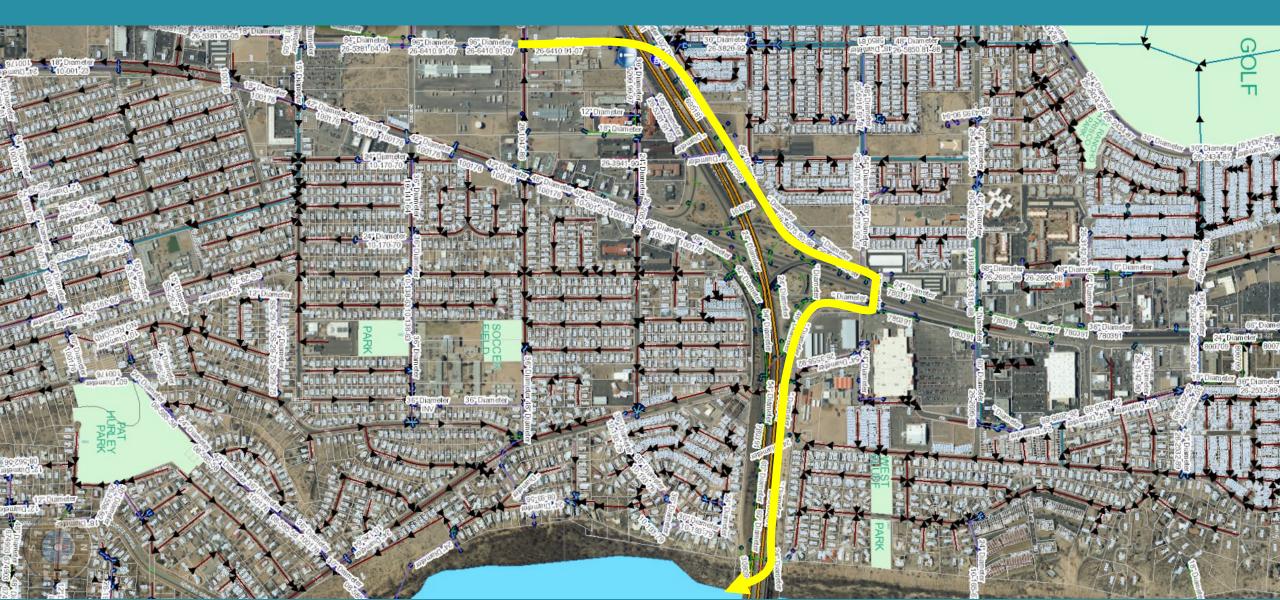
Storm Flow to Rio Grande 64th/Hanover Westside Interceptor Collapse - Emergency

- 12:45 AM Immediate notification that the overflow is reaching the river through the storm drain system to EPA, NMED and Pueblo of Isleta (POI)
- 7:30 AM Initial press release on the spill
- 10:00 AM River sample collection for E.coli begins
- All day coordination with partner agencies to identify and address any other overflow areas or problems
- 3:00 5:00 PM 24-hour notice email sent to EPA, POI and NMED
 - afternoon press release
 - virtual meeting with POI and MRGCD

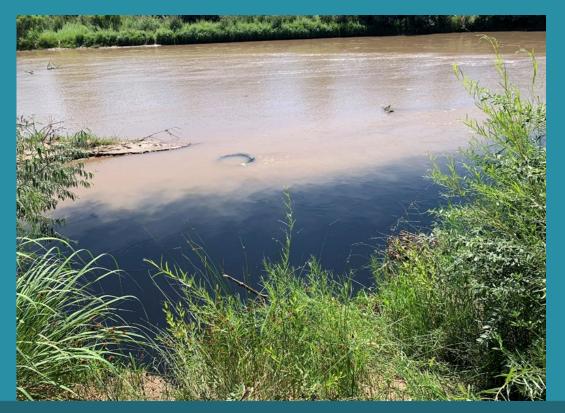
Monday during spill

Rio Grande Sample Collection
