# Advanced Metering Infrastructure

# AMI (Advanced Metering Infrastructure)

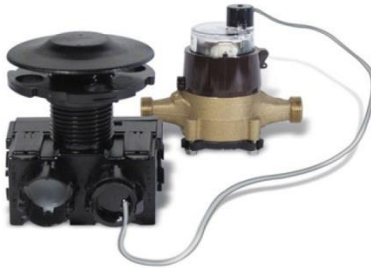
- **AMI** –refers to the equipment used to collect, store and forward information from the meter to the meter database management system(MDM).

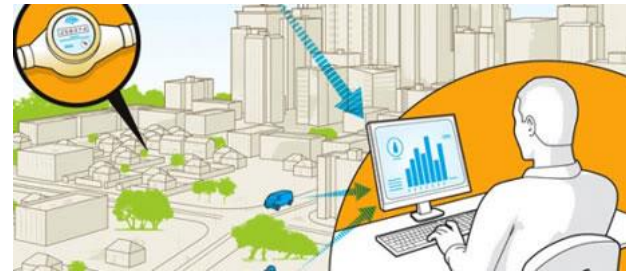
Programmer

FlexNet & Meter

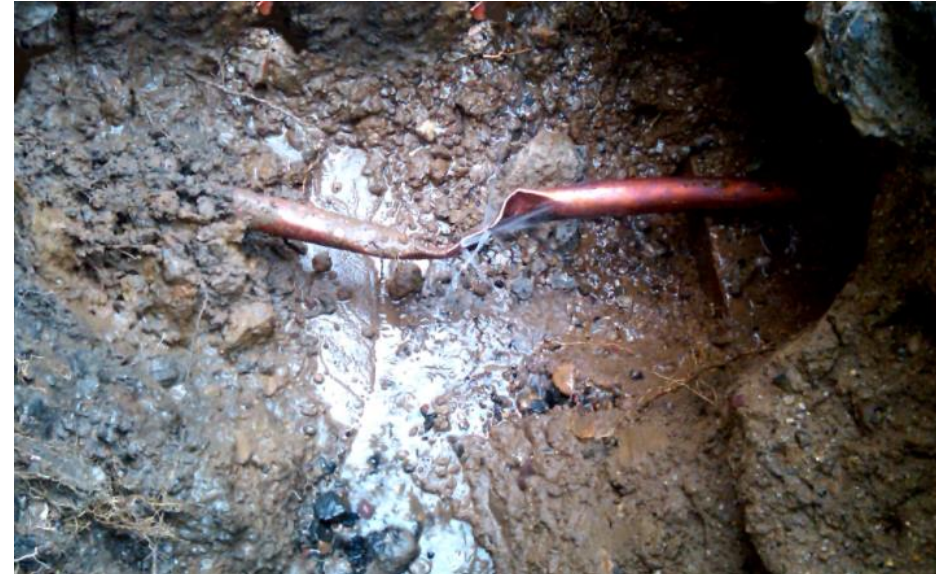
- Residential leak detection
- Pressure Monitoring
- Sewer applications
  - Vacuum stations
  - Odor control
  - SSO detection
- Large Meters
  - 30% of Revenue
  - Fast response to meter failure

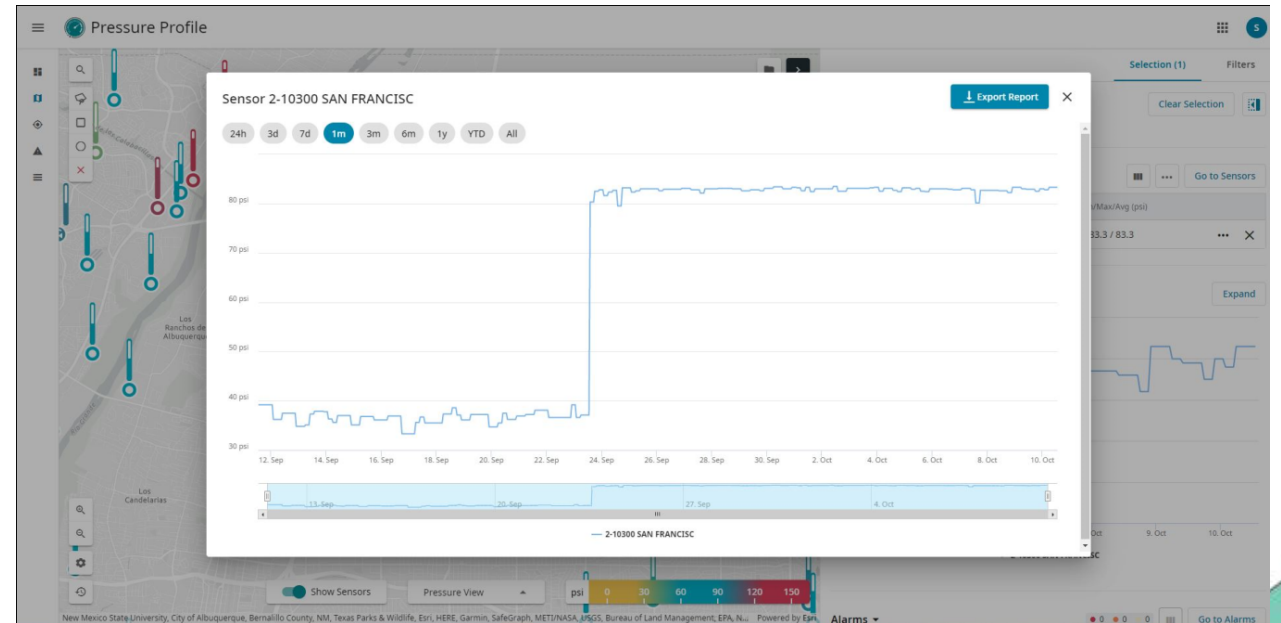
- PSV indicated a potential redundancy issue in the system, when the Alameda trunk was supplied by Palomas/Holbrook PRV
- This in turn led to Water Authority crews extending a 6" main
- Provided additional flexibility to move water across trunks
